**Grousemount Wind Farm  
County Kerry**

**Additional Information**

# PEAT STABILITY RISK ASSESSMENT

## Grousemount Wind Farm

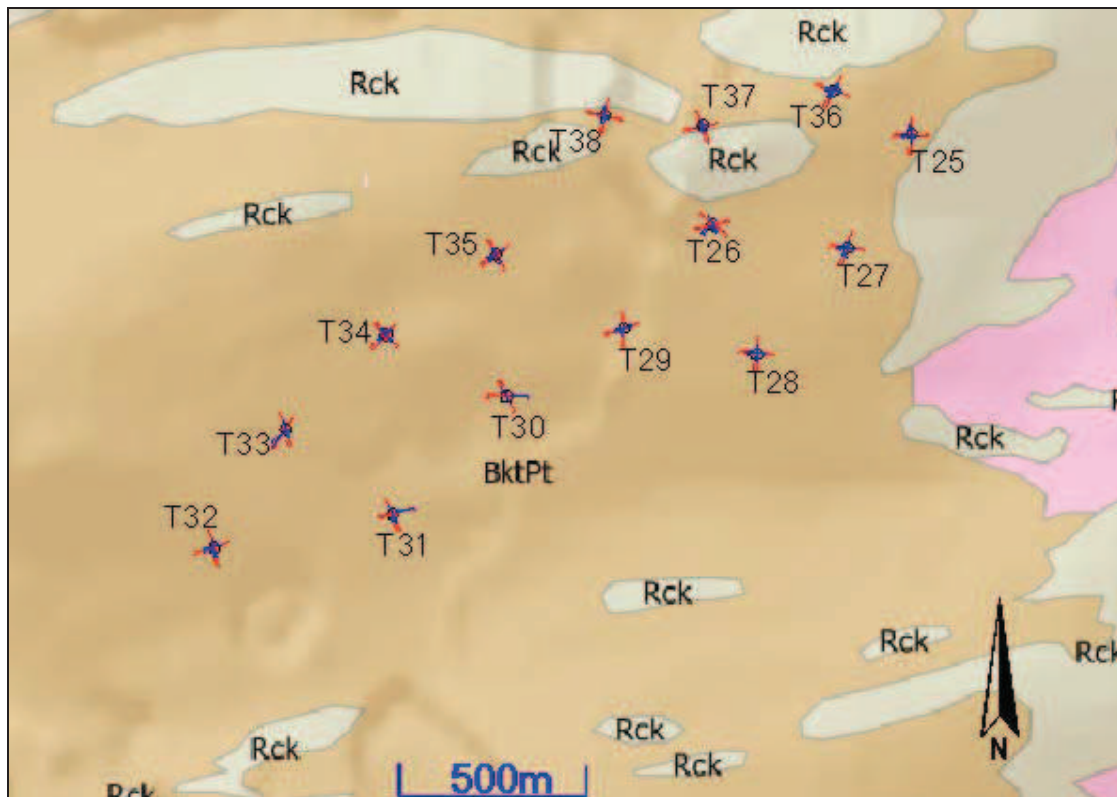
Fig. 2.3: The Teagasc soil map with blanket peat (brown), rock at surface (grey), and Devonian sandstone till (magenta).

The soil for the predominant part of the site is a layer of blanket peat on rock, with some Devonian sandstone till to the east of the site (Fig.2.3).

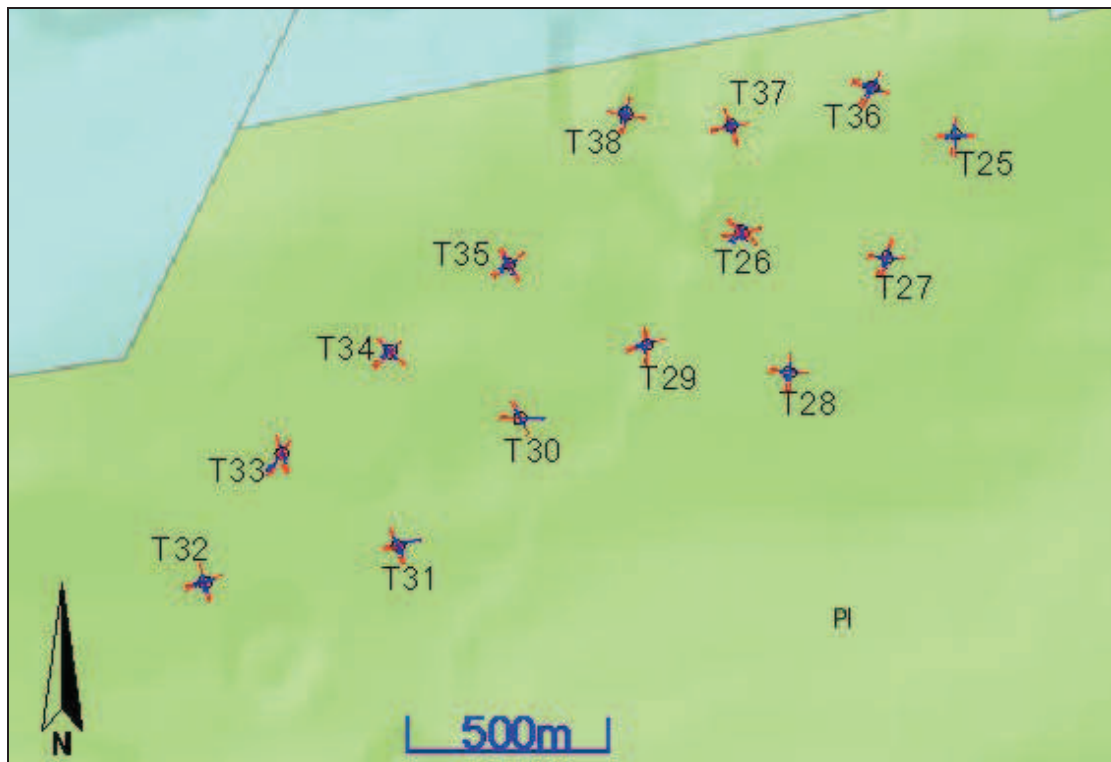
Fig. 2.4: Aquifers map for the site. Green = Poor Aquifer – Bedrock which is Generally Unproductive except in Local Zones. Cyan = Locally Important Aquifer – Bedrock which is Moderately Productive only in Local Zones.

The site of the Barnastooka Wind Farm is described as a “Poor Aquifer – Bedrock which is Generally Unproductive except in Local Zones” (Fig.2.4).

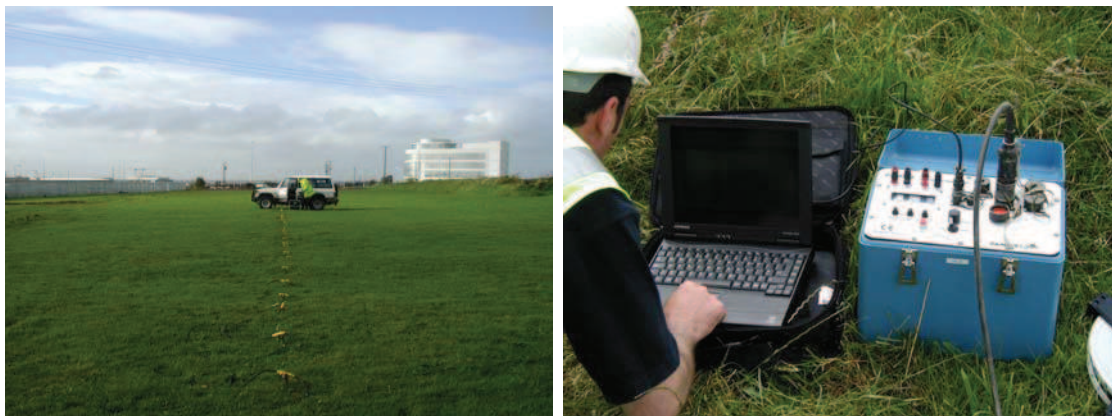
This surveying technique makes use of the Wenner resistivity array. The 2D-resistivity profiling method records a large number of resistivity readings in order to map lateral and vertical changes in material types. The 2D-resistivity profiling method involves the use of 32 electrodes connected to a resistivity meter, using computer software to control the process of data collection and storage.

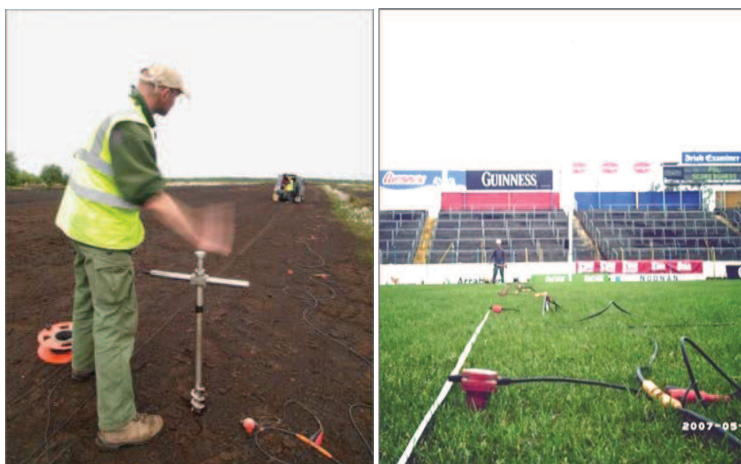
Readings are taken using geophones connected via multi-core cable to a seismograph. The depth of resolution of soil/bedrock boundaries is determined by the length of the seismic spread, typically the depth of resolution is about one third the length of the profile.( eg. 69m profile ~23m depth, 33m profile ~ 11m depth)

Shots from seven different positions were taken (2 x off-end, 2 x end, 3 x middle) to ensure optimum coverage of all refractors. All profiles were surveyed to Irish National Grid using a ProXR dGPS system.

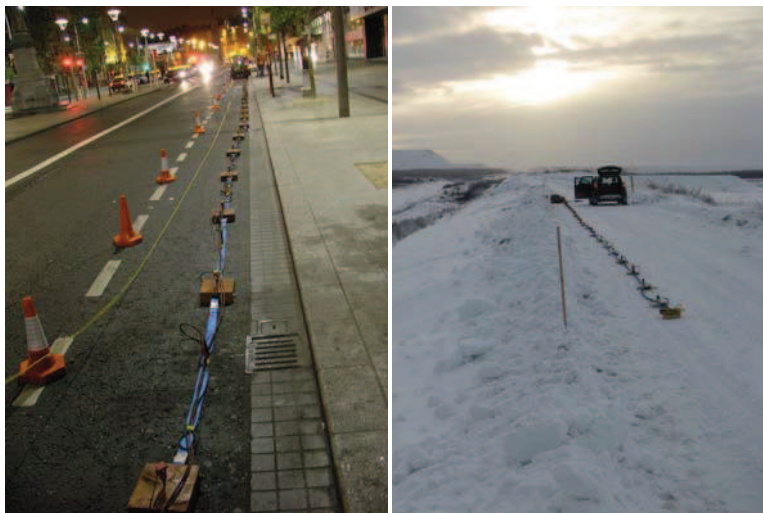
The recording equipment consisted of a Geode 24 channel digital seismograph, 24 no. 10HZ vertical geophones, hammer energy source with mounted trigger and a 24 take-out cable. Two orthogonal profiles were acquired at each of the turbine bases, with a 1m geophone spacing.

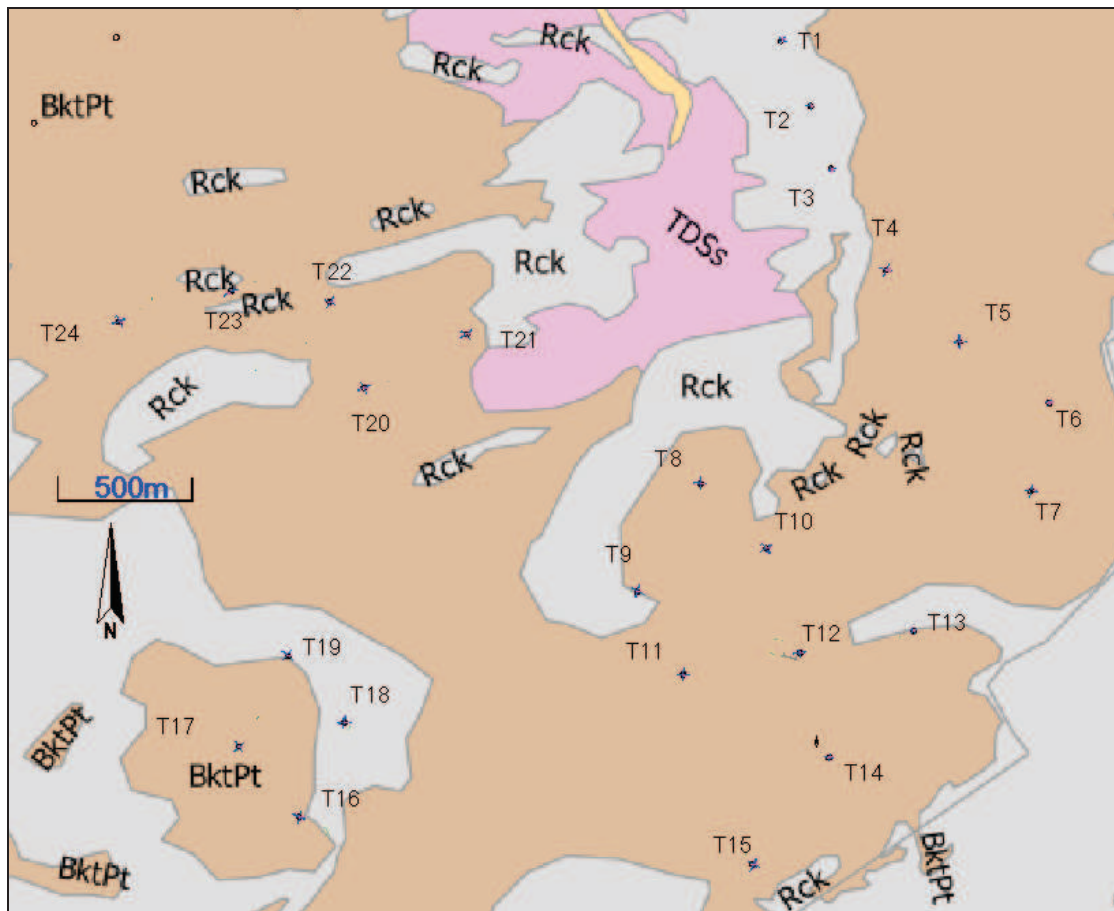
Fig. 2.3: The Teagasc soil map with blanket peat (brown), rock at surface (grey), and Devonian sandstone till (magenta).

The soil for the predominant part of the site is a layer of blanket peat on rock, with some Devonian sandstone till to the east of the site (Fig.2.3).

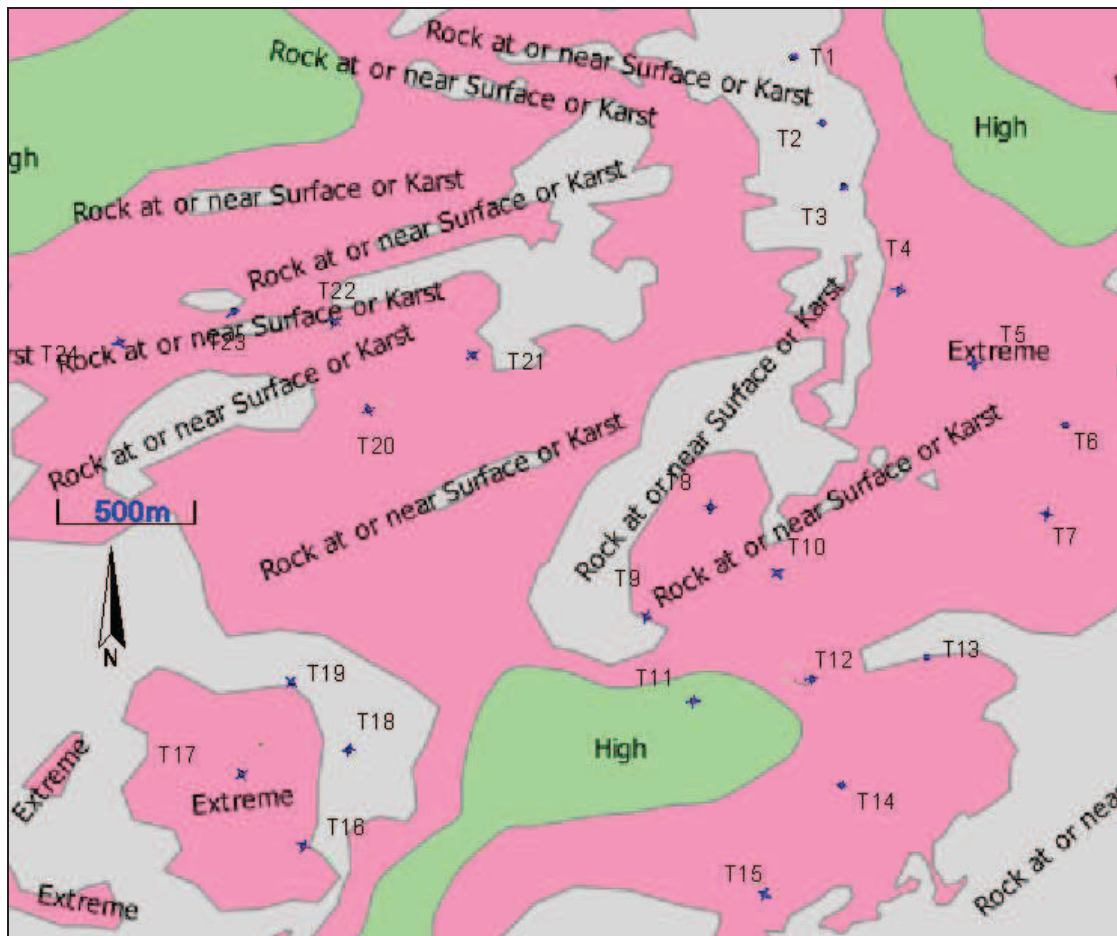
Fig. 2.5: Vulnerability map for the site. Green = High. Pink = Extreme. Grey = Rock at or near the surface.

The vulnerability for the site is either high or extreme, and also contains sections where there is rock near to the surface (Fig.2.5).

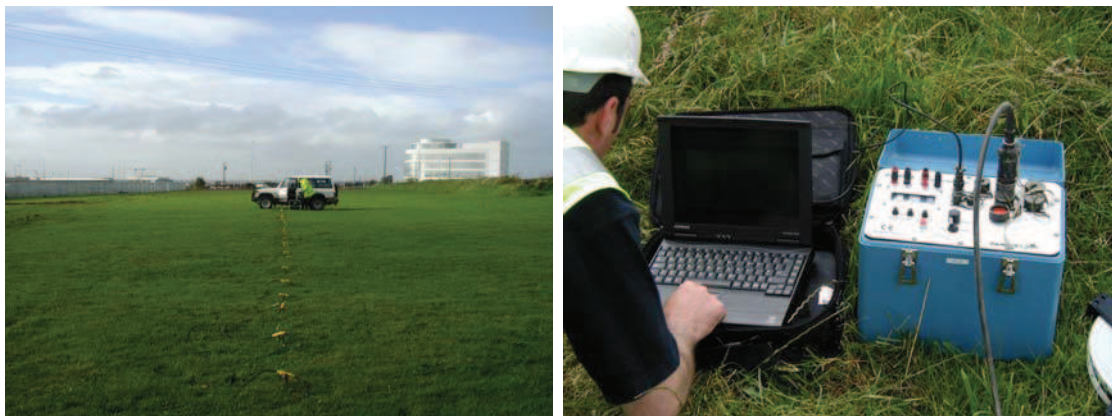
This surveying technique makes use of the Wenner resistivity array. The 2D-resistivity profiling method records a large number of resistivity readings in order to map lateral and vertical changes in material types. The 2D-resistivity profiling method involves the use of 32 electrodes connected to a resistivity meter, using computer software to control the process of data collection and storage.

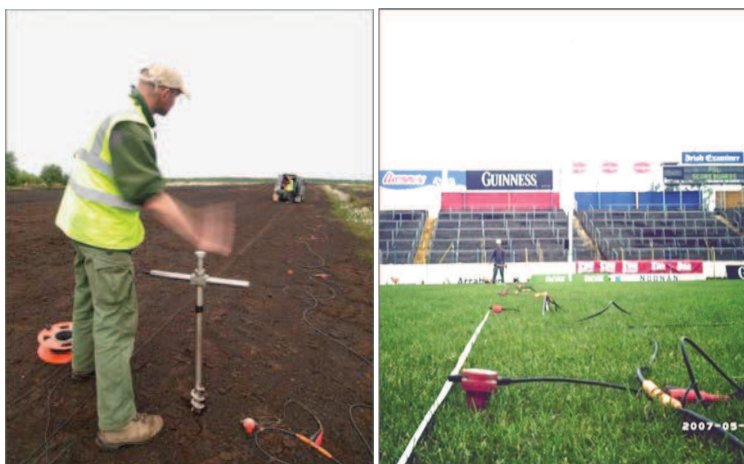
Readings are taken using geophones connected via multi-core cable to a seismograph. The depth of resolution of soil/bedrock boundaries is determined by the length of the seismic spread, typically the depth of resolution is about one third the length of the profile.( eg. 46m profile ~16m depth, 23m profile ~ 11m depth)

Shots from seven different positions were taken (2 x off-end, 2 x end, 3 x middle) to ensure optimum coverage of all refractors. All profiles were surveyed to Irish National Grid using a ProXR dGPS system.
