APPENDIX L.2

ARCHITECTURAL INVENTORY

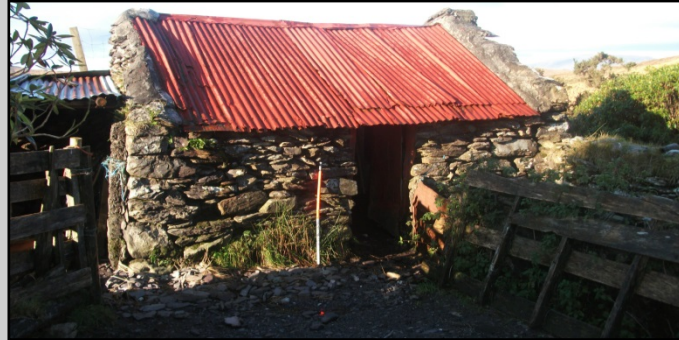
SITE CH39**TOWNLAND:**

This comprises a small single-storey former gable-ended dwelling constructed in stone; single door-ope in SE-facing façade and single squared window op on NE gable; replacement corrugated iron roof. The structure is now in use as an agricultural shed and here are small stone-built animal enclosures to SE and S, the former of which incorporates a sheep-dipping feature.

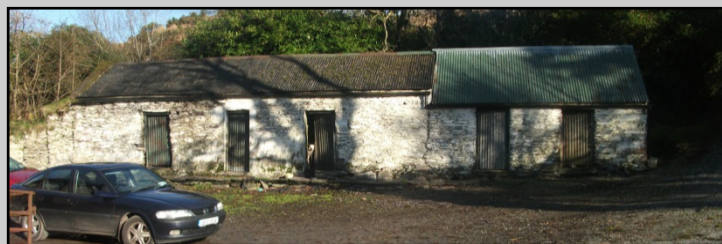
CH40A

- A. An eastern range of single-storey, gable-ended outbuildings with ridged roofs covered with sheets of corrugated iron; roofline indicates that southern section may be a later extension. The form of the northern end indicates that this may have been a dwelling, incorporating a central door and single window opes to either side.

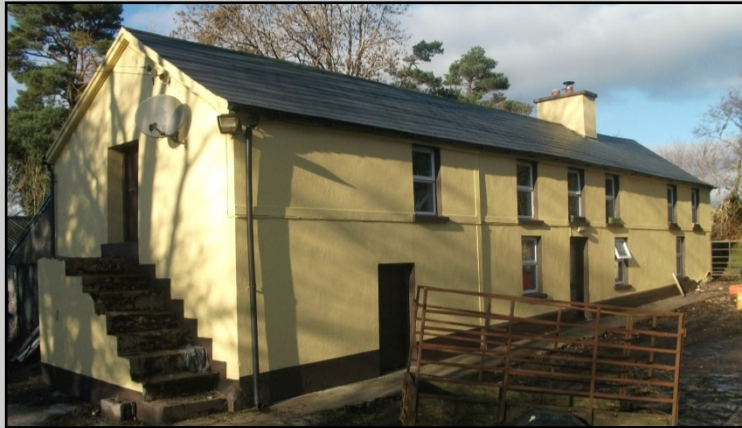
CH40B

- B. The central range comprises a two-storey habitable dwelling; gable-ended with replacement slate ridged roof and off-centre chimney. The east-facing façade incorporates a central doorway with single flanking windows; additional window to north and additional doorway to south providing access to store; six window bays to first floor; storage area on first floor of southernmost section of is accessed by external steps on southern gable.

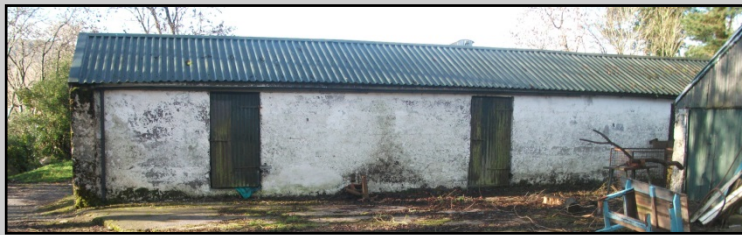
CH40C

- C. Range of single-storey, gable-ended outbuildings with ridged roofs of corrugated iron sheeting; Stone construction and painted with whitewash. The northern section of the building, incorporating a doorway and large window ope, now blocked up, may be a later extension; the southern section incorporates a central door ope and large flanking windows, all of which are blocked up; small window ope on southern gable. Access is now from rear through three modern door openings.

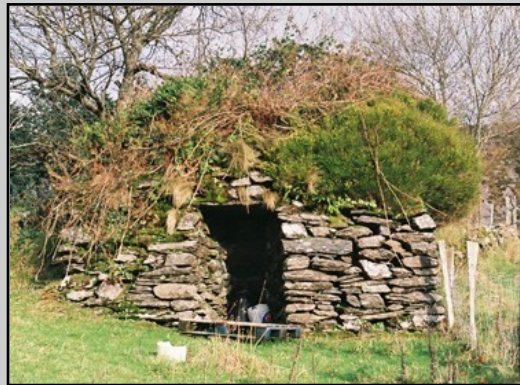
SITE CH41

This feature, of mid-late 19th century date, is constructed in stone and is partly ruinous and overgrown. The squared ope of the hearth area is on its southern façade.

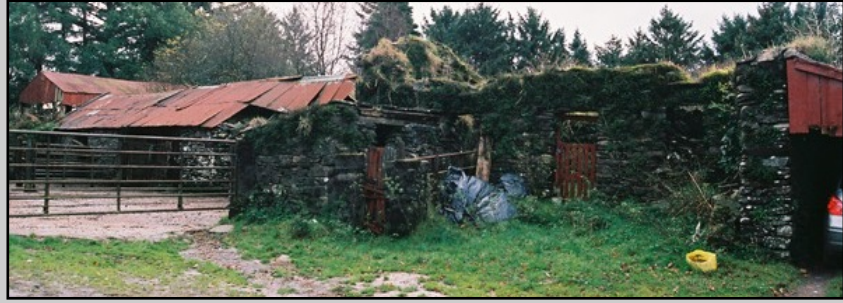
- A. Range of stone buildings orientated north-south with the eastern facades facing onto the road. In the northern side of the range is the ruined remains of a former dwelling, with internal remains of a chimney on its party wall; it originally had a central doorway with single window opes to each side. The southern end of the range, shares the chimney and is formed by single-storey structures, one of which may have formed a separate dwelling, and presently roofed with corrugated iron sheeting and used as animal housing. These all date to the early 19th century. To the south is a 20th century free-standing open barn constructed of steel uprights and with a corrugated iron roof

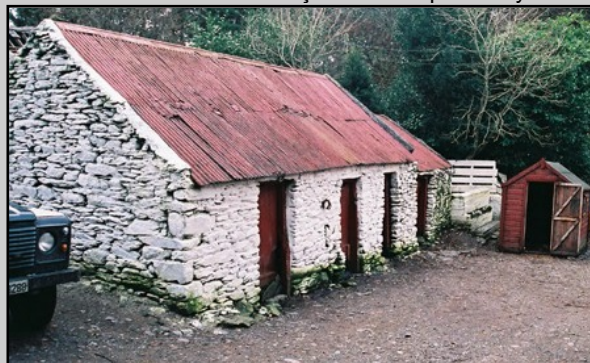
- D. To the immediate west of C are the partially ruinous remains of a range of outbuildings constructed of stone. These consist of a two-storey loft structure with a single-storey extension to west. The former is roofed with galvanised sheeting but was roofed with slate until the early 2002.
- E. Located to the south of C is a single-storey outbuilding with a small low extension to west. Of early 19th century date, this building incorporates four doors on its northern façade and is presently roofed with galvanised sheeting.

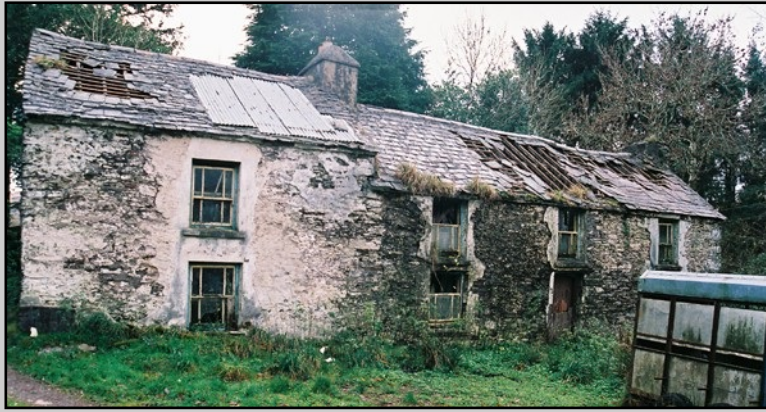
- F. Located to the south of E are the semi-ruinous remains of a gable-ended, four-bay, two-storey former dwelling orientated east-west with façade facing north; The original gables incorporate chimneys and the structure was subsequently extended to the east and the roof of the overall structure was originally of slate. This is of early 19th century date.

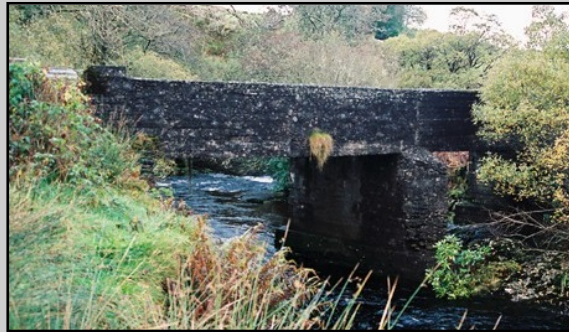
SITE CH43

This two-span concrete bridge over the Roughty River was constructed in the 1950s. It provides access to former dwellings in Knockanruddig townland. Prior to its construction, access was by means of a segmented road of large stones at a fording point, all of which were washed away by flooding in the early 1950s.

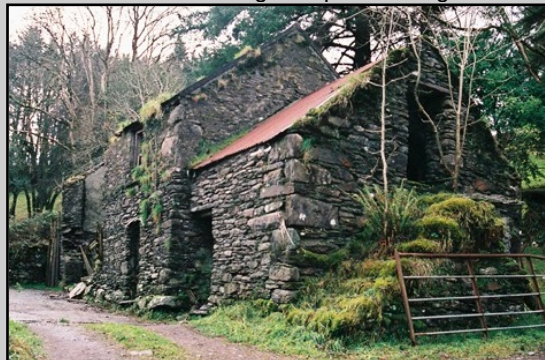
- (a) Two-storey former dwelling with a small single-storey extension to side; some evidence to indicate that the dwelling was originally a single-storey cottage. Much of the building collapsed during winter storms of 2007-8.

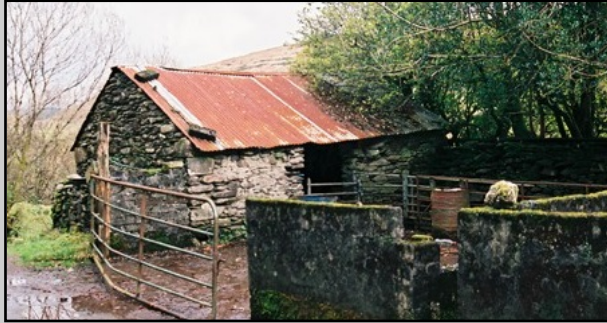
- (b) There are two stone-constructed outbuildings to the site; one to the rear of the dwelling is very ruinous and overgrown while the other, to the front, has a galvanised roof and is used for storage.

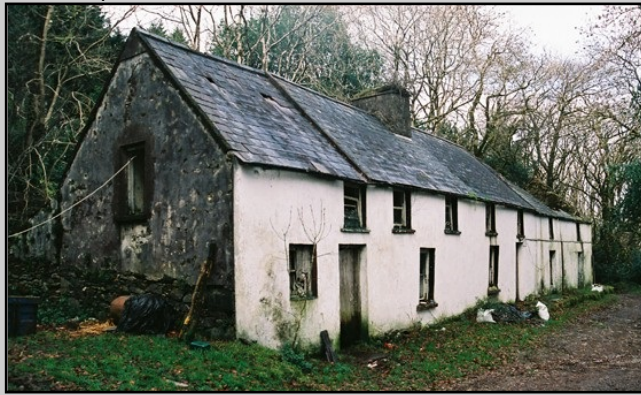
- (a) An abandoned two-storey three bay dwelling with central chimney; blocked up central doorway; building was extended to north and south with present access doorway in southern extension; part of roof to northern extension has collapsed.

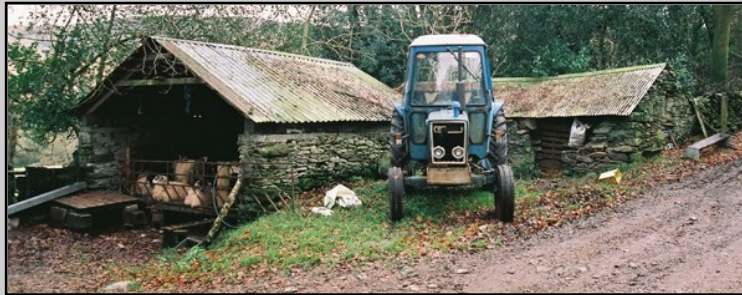
- (b) A partially ruinous stone outbuilding, now incorporating a low galvanised roof is situated to the front of the dwelling and used as an animal house. In addition, there is a modern concrete and steel barn to the south of the farmyard.

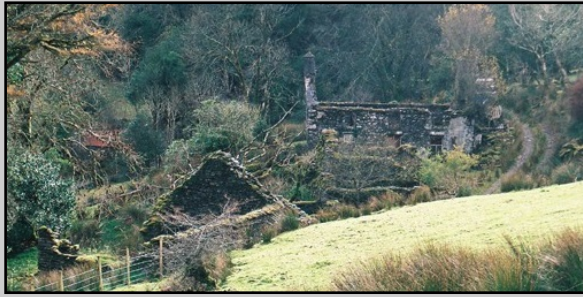
SITE CH46

This site comprises the ruined remains of a former agricultural farm of late 19th century date situated on the eastern side of an access trackway and on a platform overlooking the Roughty River.

- (a) A ruinous two-storey three-bay gable-ended dwelling with central doorway; constructed of stone and orientated east-west, with chimneys in each gable.
- (b) Two former single-storey outbuildings extend to the north alongside the road; both are single-storey, orientated north-south and in a general ruinous condition.

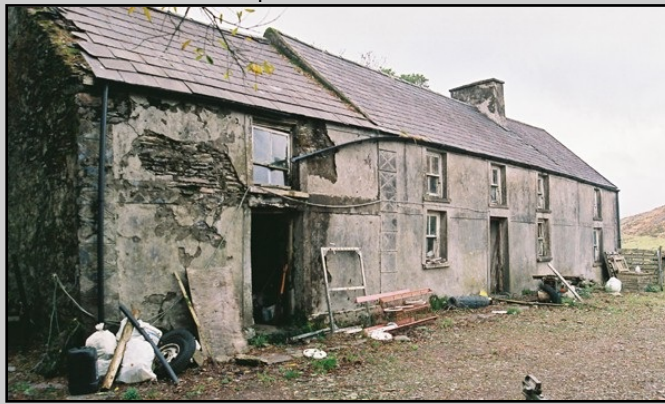
- (a) A disused former dwelling orientated north-south with façade on east, incorporating an original two-storey, three-bay house with central doorway and chimney on original northern gable; two-storey extensions to north and south forming a single, gable-ended range with a ridge slated roof; stone construction with a plaster render.

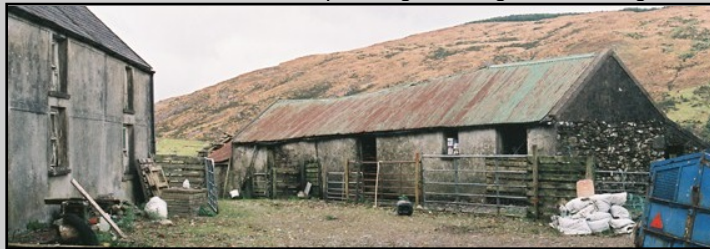
- (b) Single-storey detached gable-ended outbuilding incorporating three doorways and two small windows on its west-facing façade; largely covered with a concrete render and incorporating a corrugated iron ridged roof.

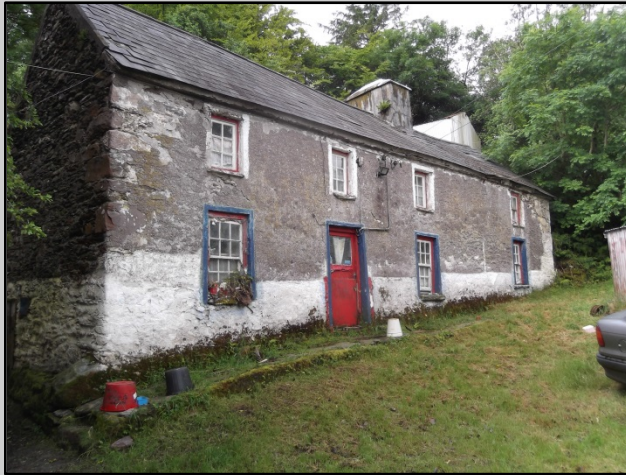
- (a) A relatively recently abandoned former dwelling orientated east-west with façade on north, incorporating a two-storey, four-bay house with doorway in eastern half and off-centre chimney; gable-ended; ridge slated roof; stone construction with a plaster render; square-headed window opes with timber six-pane windows on first floor and six-over-six pane sash windows on ground floor; replacement timber door; lean-to extension to rear.

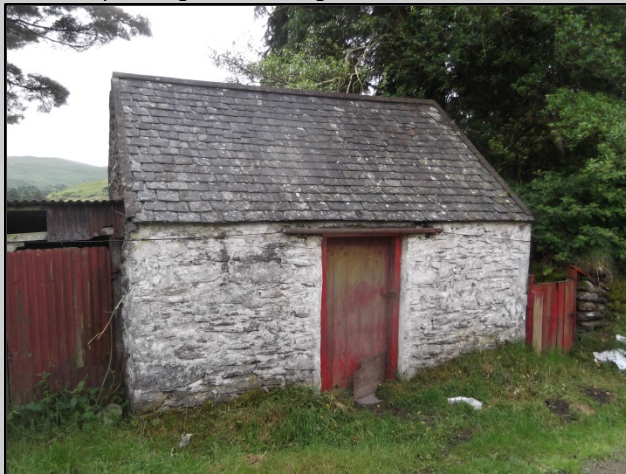
(b) Single-storey detached gable-ended outbuilding incorporating single central doorway in west-facing façade; largely covered with white-washed render and incorporating a slated ridged roof.

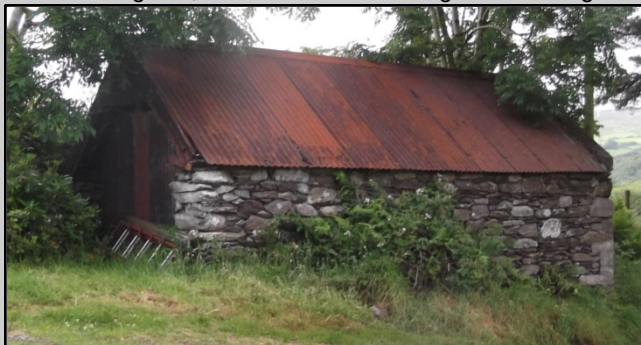
(c) Single-storey detached gable-ended outbuilding incorporating single doorway in west gable; stone faced with corrugated-iron ridged roof.

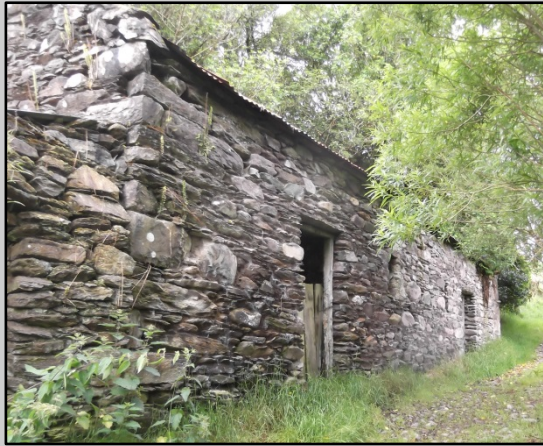
SITE CH49

This site is located on the edge of a trackway and comprises the following: Stone-built farm building of late 19th century date; orientated east-west with façade on north, gable-ended single-storey structure with two square-headed doorways and slit window/light opes on façade; small two-over two window frame set in a square-headed ope on east-facing gable; corrugated-iron ridged roof with a low lean-two extension with pitched corrugated-iron roof attached to east gable with separate doorway in north façade.

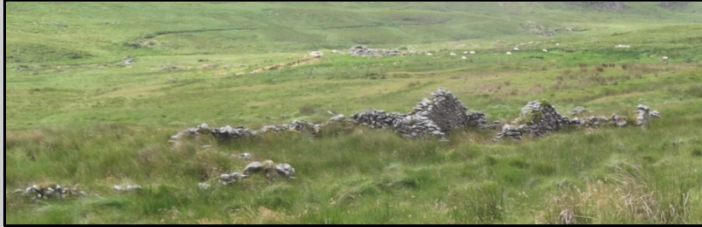
SITE CH50

This comprises the ruinous remains of a single-storey structure of early 19th century date comprising stone-built gables surviving to almost full-height and low side walls, largely tumbled; orientated north-south; no evidence for a formal chimney. Structure is set in a former filed complex, for which very little evidence now survives except for a few short-stretches of dry-stone walling.

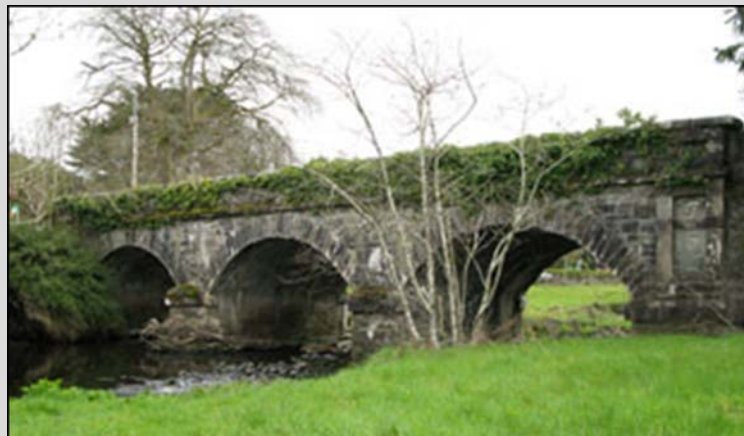
Downstream elevation

This structure is located at the western end of Ballyvourney village and provides a crossing over the River Sullane for the road to Kilgarvan. It comprises a triple-arch bridge, built c. 1830, with various recent alterations. Rubble and cut limestone construction with V-cutwaters and limestone voussoirs to segmental arches; cut limestone pilasters, piers, coping and string course.

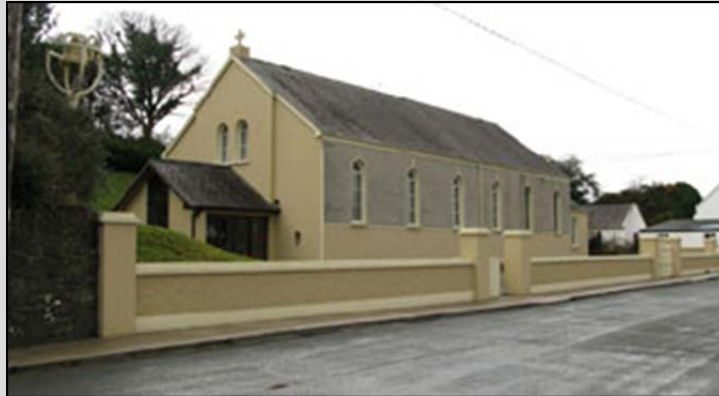
From east

This structure comprises a freestanding, gable-fronted, Roman Catholic church, built 1871, with breakfront to west and recent extensions (east and west); 6-bay nave and single-bay, single-storey sacristy (west). Pitched slate roofs with rendered chimneystack, gabled cross finial (east) and cast-iron rainwater goods; painted smooth rendered and pebble-dashed walls with plat band and round-headed holy water font; round-headed openings with two-over-two timber sliding sash windows

and stained glass windows, having dressed limestone and concrete sills. Round-headed openings with single and double-leaf panelled doors. The street-frontage boundary comprises smooth and roughcast walls and cast-iron gates.

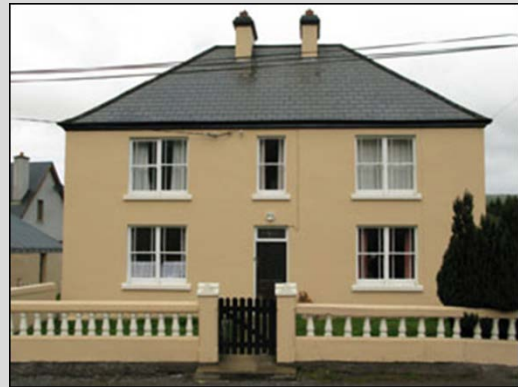
Front/south façade

This structure comprises a detached 3-bay, 2-storey house, over basement, built 1942, with extension to rear. It incorporates a hipped artificial slate roof with rendered chimneystacks and cast-iron rainwater goods; painted rendered walls; square-headed openings with three-over-three timber sliding sash windows, set in single and paired arrangements, with concrete sills; square-headed opening with timber panelled door and over-light. The street-frontage boundary comprises rendered walls with a timber gate.

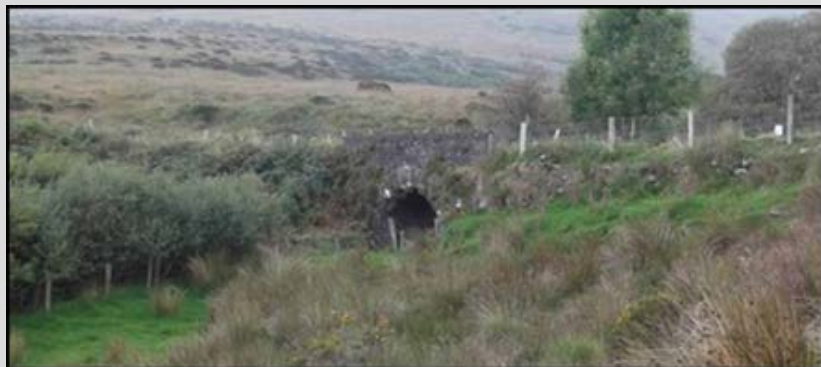
View from east

Single segmental-arched bridge of stone construction over Garrane River; late 19th/early 20th century; stone parapets with concrete coping; flat road deck. Ground built up on either sides of valley to accommodate road.

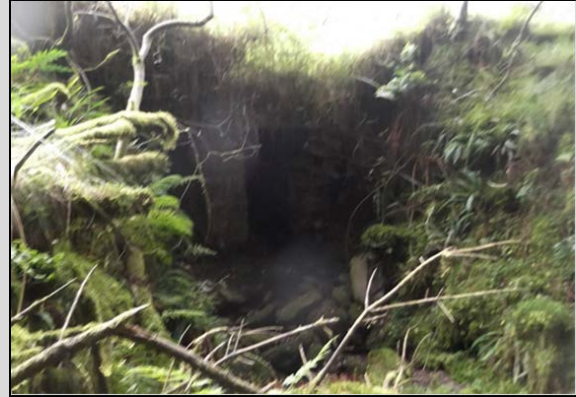
View from south

Stone bridge/culvert with central column; flat-roofed channels with flat road deck and no discernible parapet walls. Constructed in late 19th/early 20th century over a stream tributary of Foherish River. Valley/gorge built up on either side to accommodate road.

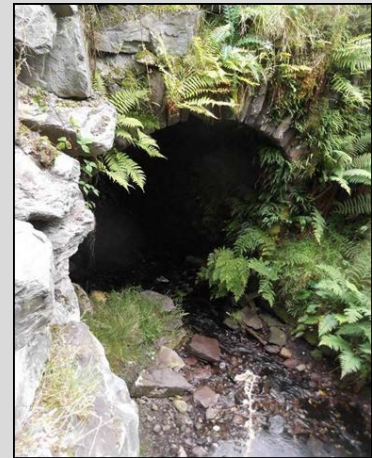
North façade

Single segmental-arched stone bridge over Foherish River; late 19th/early 20th century construction; flat road deck and no discernible parapet walls; boulders placed along stream banks to north of bridge in recent times and narrow valley built up on either side of bridge to accommodate road

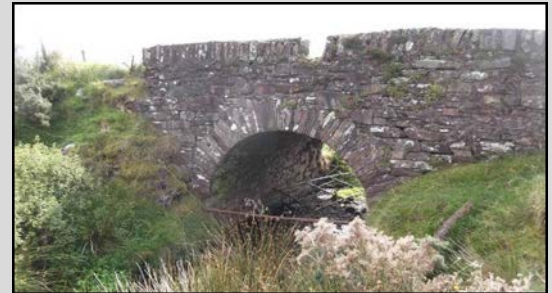
North façade

Single segmental-arched bridge over upper Bohill River; stone construction; late 19th/early 20th century date replacing a 'ford' marked on 1st ed. O.S. map. Flat road deck with stone parapet walls and edge coping; ground built up on either side of watercourse to accommodate road.

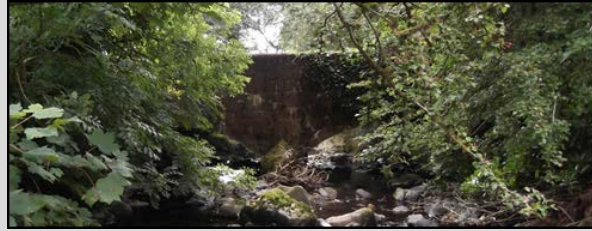
From upstream

Single segmental-arched bridge of fine cut stone over Bohill River; built late 19th /early 20th century replacing 'stepping stones' marked on 1st ed. O.S. map. Flat road deck with largely overgrown stone parapet walls and coping.

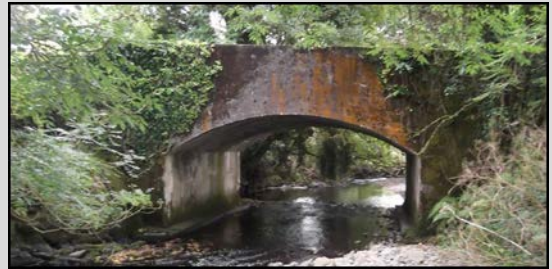
Southern elevation

Single segmental-arched bridge over Bohill River; built late 19th /early 20th century replacing 'stepping stones' marked on 1st ed. O.S. map. The entire structure incorporates a concrete render associated with repairs undertaken towards end of 20th century. Flat road deck.

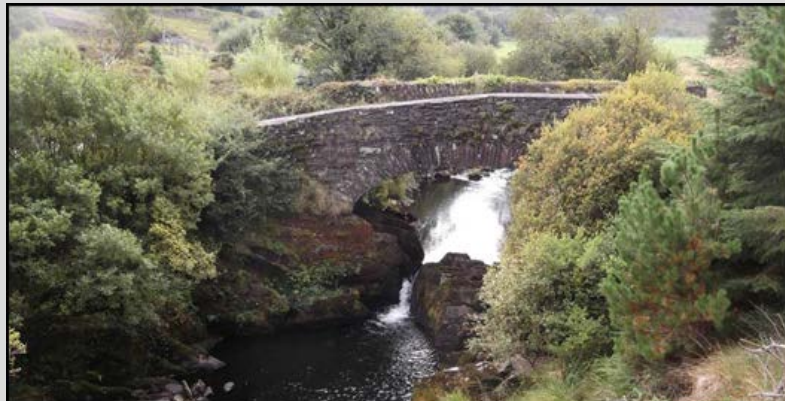
North elevation

Single segmental-arched stone bridge; of probable early 19th century date. Stone parapet walls with stone edge coping topped with concrete render. Slight hump on road deck. Bridge spans a gorge and is constructed on outcropping bedrock.

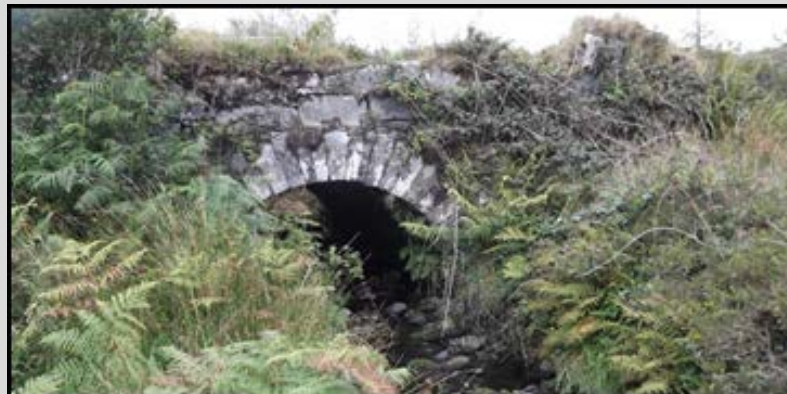
South elevation

Single segmental-arched stone bridge; of probable early 19th century date and marked on 1st ed. O.S. map Stone parapet walls barely visible above road surface.

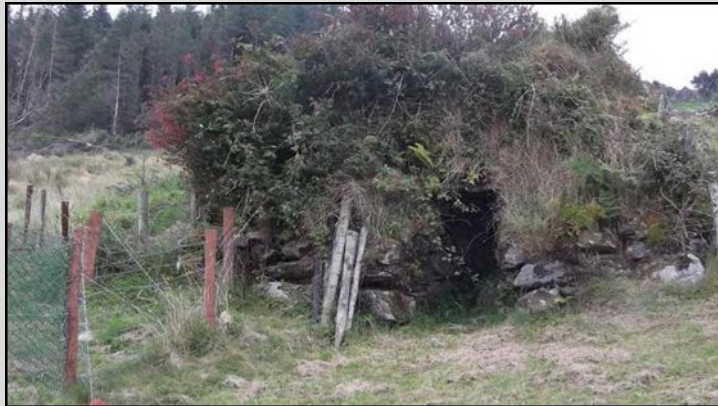
Front/South façade

This structure is located on the northern side of the Ballyvourney – Kilgarvan road and is not marked on any O.S. maps. It comprises an overgrown and partially collapsed lime kiln of probable 19th century construction; front elevation has a lintelled recess with sloping slabs to rear; set back from the road and adjacent a trackway.

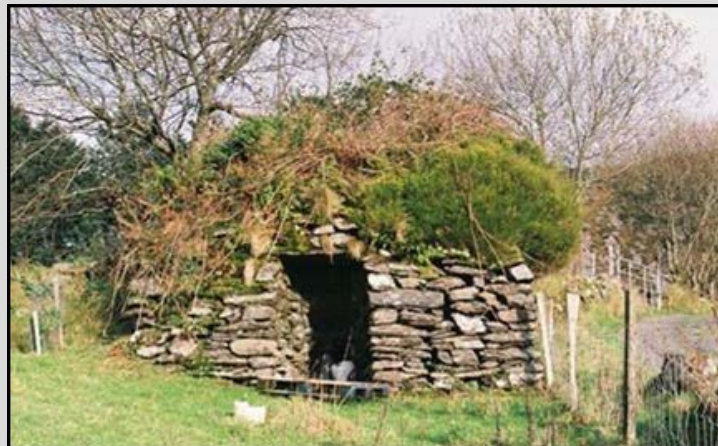
Front Facade

This feature, of mid-late 19th century date, is constructed in stone and is partly ruinous and overgrown. The squared open of the hearth area is on its southern façade.
