# APPENDIX L.3 ARCHAEOLOGICAL MONITORING REPORT (JOHN CRONIN & ASSOCIATES)

## Barnastooka Windfarm, Kilgarvan, Co. Kerry **Archaeological Test Trenching**

Kerry County Council ref. 10/197 Excavation Licence: 10E0201

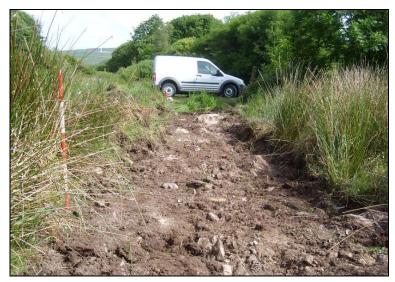
The proposed temporary compound area is located adjacent to the south of an existing trackway on the northeast boundary of the landholding. The compound site, which measures 25m x 20m, consists of a level area of rough pasture with a stream running along its northern boundary. Trenching revealed a shallow layer of brown peaty topsoil averaging 20cm in depth that overlay a stony, greyish brown sandy clay subsoil (Plate 1). No features of an archaeological nature were noted.

Plate 1: Trench in proposed temporary compound, view to north

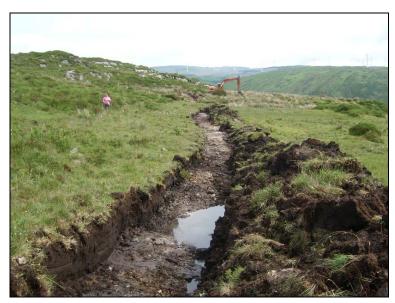
west direction before reaching a narrow stream (107043/73487). The trench revealed a layer of peaty topsoil, which varied in depth from 0.4m-0.5m at northeast end of the trench to 0.7m at the southwest, and overlay the undulating, stony, greyish brown, clay-rich subsoil in all areas (Plate 2).

Plate 2: Proposed entrance route between 107112/73576 and 107043/73487 (view from northeast)

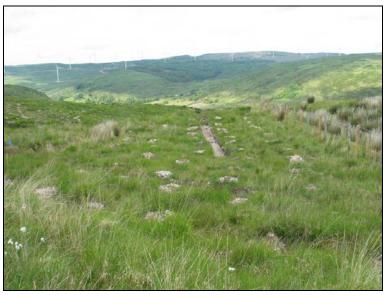
Plate 3: View of proposed entrance route showing recent tree planting

The c.500m section of the proposed entrance route that has been recently been planted with trees was not available for test trenching. The plantation has extensively truncated the surface of the natural subsoil and nothing of archaeological significance was noted during two separate walkover surveys of this area. It was not possible for the mechanical excavator to operate in the steeply sloping area of hillside in the vicinity of Turbine 14. This area was also inspected on two separate occasions and it is concluded that, given the steeply sloping gradient, it has a low archaeological potential.

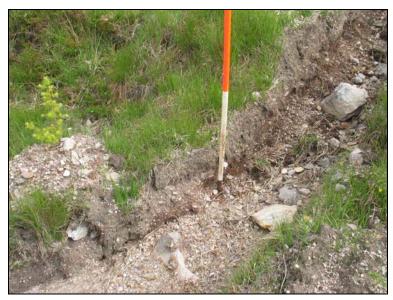
Plate 4: Detail of disturbed soil profile in tree plantation

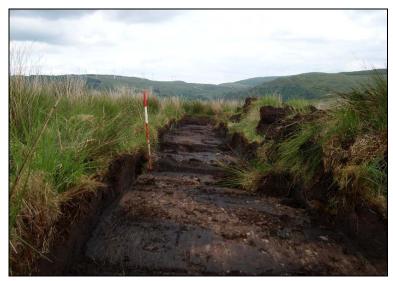
**Proposed control building:** The site of the proposed control building compound (107282/72698) consists of an area of ground close to the foot of the northern slope of a hill. The ground is poorly drained and boggy with dense stands of rushes. Two east-west orientated 30m long test trenches were excavated, at 10m intervals, across the compound site. The trenches revealed a layer of peaty topsoil, varying in depth from 0.4m to 1m, which overlay a greyish brown, boulder clay with inclusions of bedrock fragments (Plate 5). No features or deposits of an archaeological nature were observed.

Plate 5: Proposed compound site: Southern test trench, view to east

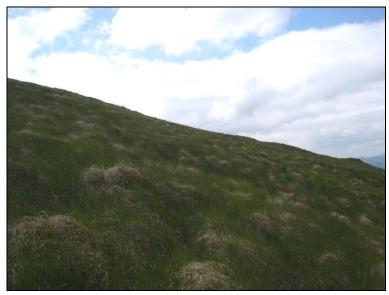
Plate 6: View of steep slopes in vicinity of Turbine 14

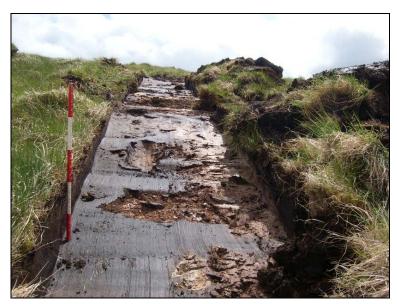
**Turbine 14:** This turbine site (106927/72342) is located on a steep north facing slope, just below the summit of the hill. Two 30m long trenches were dug across the proposed turbine site. Both revealed a dark brown peaty topsoil layer, 0.2m deep, overlying a greyish brown clay subsoil with inclusions of bedrock fragments (Plate 7). No features or deposits of an archaeological nature were noted.

Plate 7: Test trenching at Turbine 14

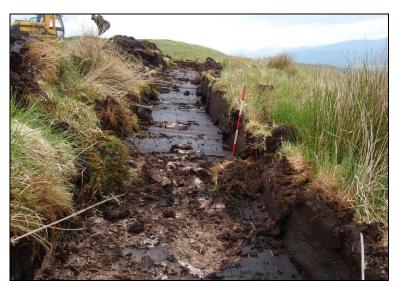
**Turbine 13:** This turbine (107258/72313) is located on a steep, north-facing slope, just north of the summit of the hill. Two 40m long trenches were dug across the site revealing a dark brown peaty layer, 0.6m in depth, overlying the greyish brown boulder clay subsoil (Plate 8). No features or deposits of an archaeological nature were observed.

Plate 8: Test trenching at Turbine 13, view looking westwards

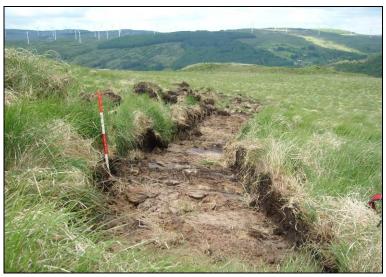
A trench was excavated along the line of this section of the proposed route, which measures *c*.600m in length and runs in an east-west direction along a ridge on the south side of the summit of the hill. A dark brown/black peaty layer, ranging between 0.2m and 1m in depth, was exposed overlying the greyish brown boulder clay and no features or deposits of an archaeological nature were observed (Plate 9).

**Plate 9:** Test trench extending between Turbines 1 & 2

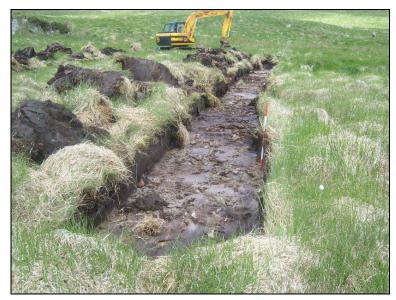
**Turbine 3:** Two 40m long trenches were dug across the proposed turbine site (107635/71942) at 10m intervals and exposed a dark brown peaty topsoil layer, averaging 0.5m deep, overlying a light yellowish brown, boulder clay subsoil (Plate 10). No features or deposits of an archaeological nature were noted.

**Plate 10:** Test trenching at Turbine 3

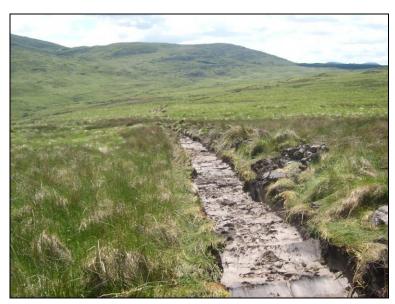
A continuous trench was excavated along this section of the proposed route, which extends in a southwest direction across a gently inclining south-facing slope before turning northwards to Turbine 6. The shallow dark brown peaty topsoil layer in this area averaged 0.2m in depth and overlay the light yellowish brown, boulder clay subsoil (Plate 11). No features or deposits of an archaeological nature were observed.

**Plate 11:** Test trench extending between Turbines 5 & 6

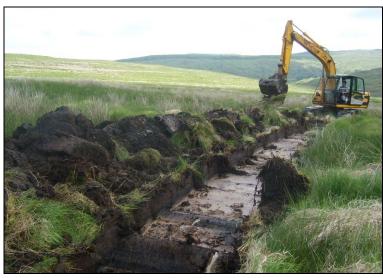
**Turbine 6:** Two 40m long trenches were dug across the proposed turbine site (106720/71542) at 10m intervals and exposed a dark brown peaty layer, averaging 0.3m deep, overlying a light yellowish brown, boulder clay subsoil (Plate 12). No features or deposits of an archaeological nature were noted.

**Plate 12:** Test trenching at Turbine 6

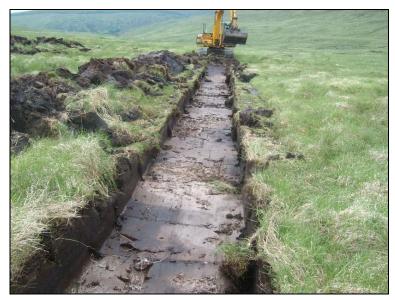
**Turbine 8:** Two 40m long trenches were dug across the proposed turbine site (105933/71132) at 10m intervals and exposed a dark brown peaty layer, averaging 0.5m deep, overlying a light yellowish brown, sandy boulder clay subsoil (Plate 8). No features or deposits of an archaeological nature were noted.

**Plate 13:** Test trenching at Turbine 8

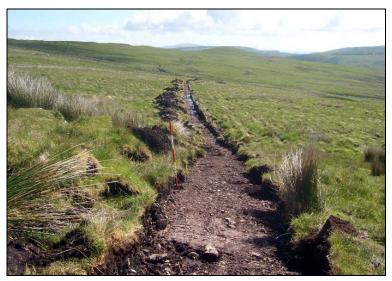
A continuous c.500m long trench was excavated along this section of the proposed route, which extends in a northeast direction across a gently inclining, south-facing slope towards Turbine 11. The dark brown peaty topsoil layer in this section of the route averaged 0.2m in depth and overlay the light yellowish brown, stony, sandy boulder clay subsoil (Plate 14). No features or deposits of an archaeological nature were observed.

**Plate 14:** Test trench extending to Turbines 10 & 11

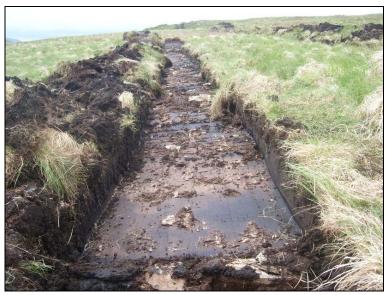
**Turbine 10:** Two parallel 40m long trenches were excavated at 10m intervals at this turbine site (106396/71708) located on an area of level ground on a south-facing slope. Trenching exposed a dark brown peaty layer, averaging 0.2m deep, overlying a light yellowish brown, sandy boulder clay subsoil with inclusions of bedrock fragments (Plate 15). No features or deposits of an archaeological nature were noted.

**Plate 15:** Test trenching at Turbine 10

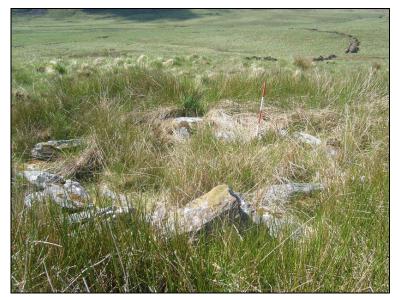
The foundations of this sub-circular hut site were identified on a level terrace on the south-facing slope, *c*.30m north of the proposed route between Turbines 9 & 10. The collapsed wall

measured up to 2m in thickness and enclosed an internal area measuring 2.06m north-south by 2.7m east-west (Plate 16).

Plate 16: View of North Hut from northeast

There are no recorded archaeological monuments within the proposed development site and no archaeological features, deposits or artefacts were identified in the test trenches excavated on the footprint of the proposed development. Two previously unrecorded, sub-circular, drystone hut sites were noted with the southern end of the overall land-holding. These hut sites are not on the footprint of the proposed development but it is recommended that they are clearly cordoned off during construction works within buffer zones extending for 20m from their walls. This is to prevent any accidental disturbance to the huts by construction traffic.

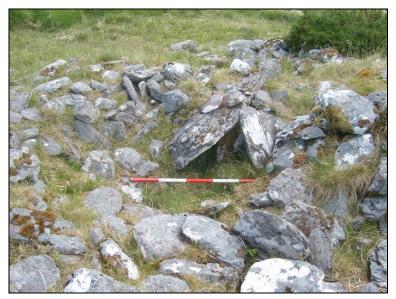
The foundations of this sub-circular hut site were identified on a level terrace on the south-facing slope c.40m south of the proposed route between Turbines 6 & 7. The collapsed wall measured up to 1.5m in thickness and enclosed an internal area measuring 1.6m north-south by 2m east-west. A 1m wide gap in the east wall appeared to form the entrance (Plate 17).

Plate 17: View of interior of South Hut from west
